Well I have gotten a good start on the 1995 RIALTA makeover. After replacing the resistors in the dash A/C I found out that the 4 speed switch has some issues it works but it takes some jiggling on the middle speeds, I'll get a new ordered next week. The rear A/C was a different story. This unit has a 3 speed fan motor and the 2 low speeds were out. To get to the fan you have to remove the headliner.

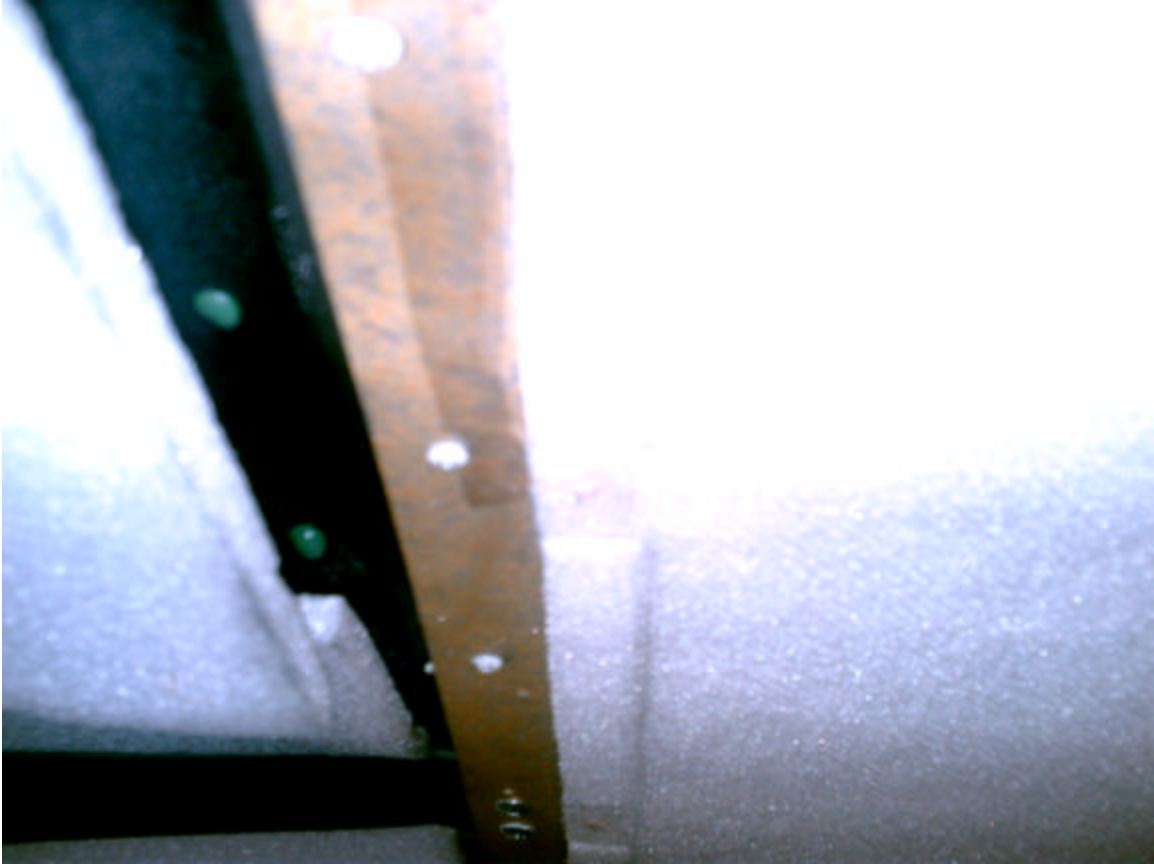
When I lowered the headliner a half dozen sheet metal screws fell out from behind it. They were just laying loose in the headliner. Upon inspection I discovered the location of these screws. Winnebago joins the VW cab to the motor home body with some impressive steel and glue. The primary seam is an interlocking Z arrangement. This is what holds the roof together as well as **UP** and the aforementioned screws were from this joint. Upon inspection of the room seam I found that it had separated and sagged down about 1/2 inch in places. Someone had caulked it so there was no leak but with out the screws there was nothing to hold the roof up so caulking was just a temporary fix. I am going to remove all the screws then clean all the caulking from the seam and re-caulk it and the install new screws.

The "Roof Seam" if your roof has a gap between the forward cab and the motor home body this is where the problem is just caulking the gap is NOT the FIX!

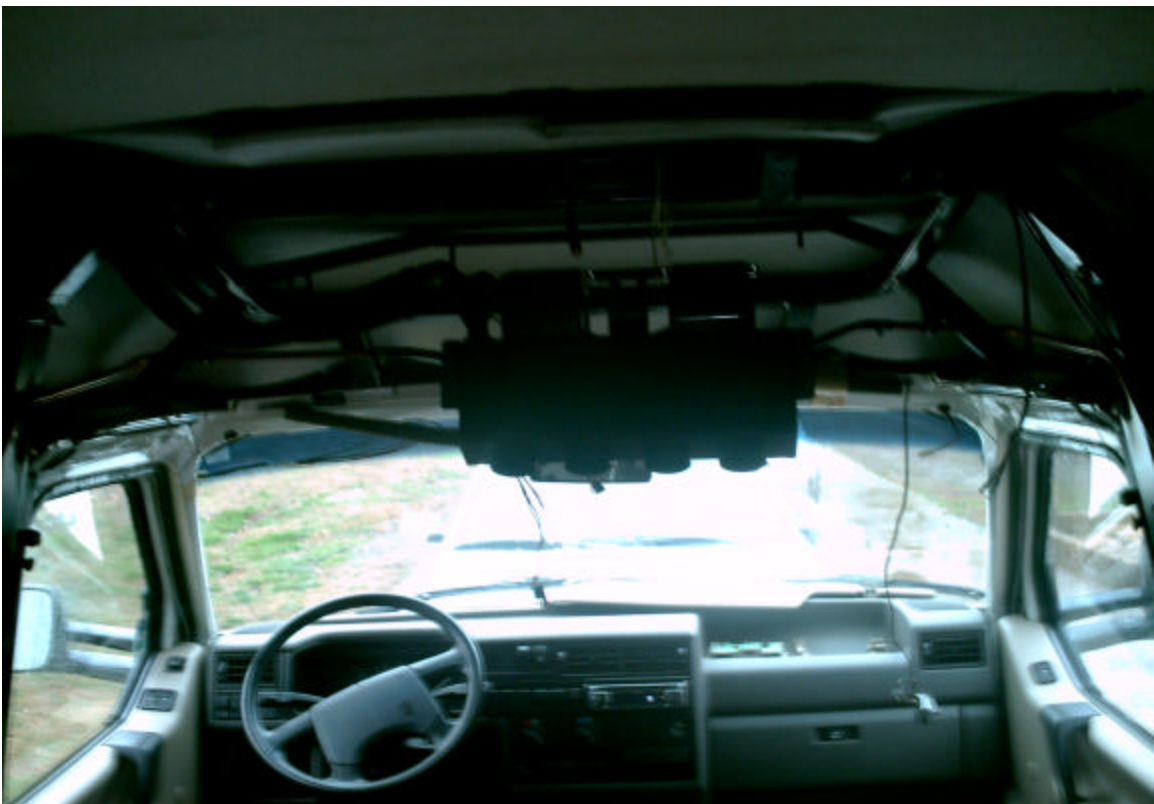
With the headliner removed I was able to get to the A/C unit and remove the fan. This requires dropping the A/C housing and separating the plastic case to remove the fan. The fan is a standard 3 speed Fasco D135 model; I ordered one off the internet for \$40.00.

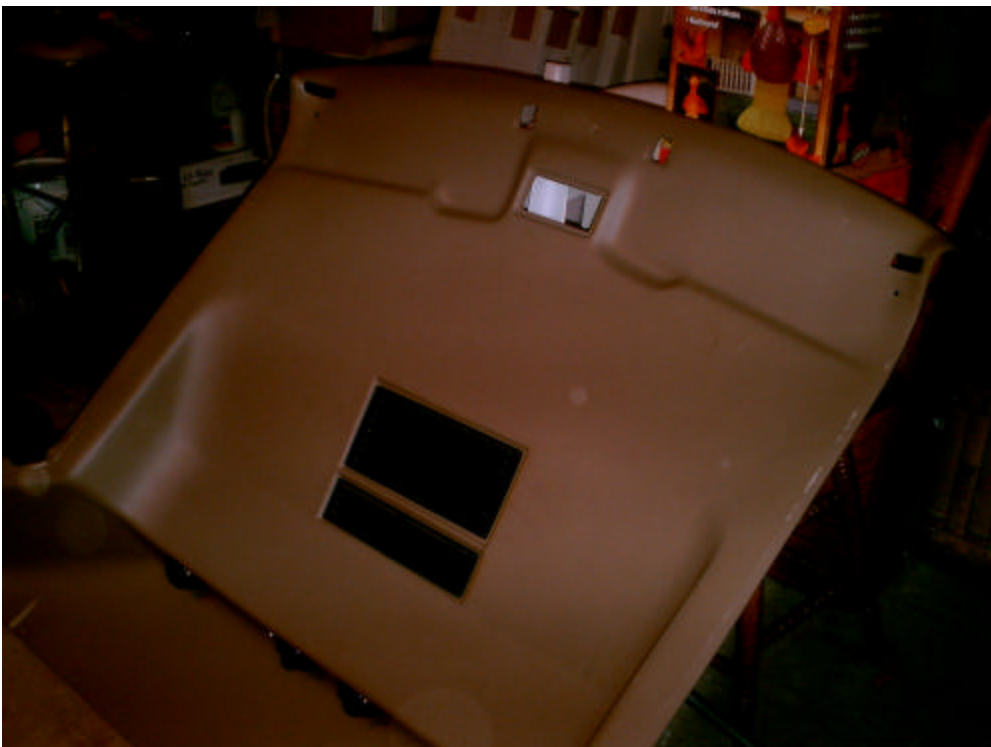
I am adding an 11 inch drop down monitor just behind the overhead A/C vents. This monitor will be tied to a Legacy LTV52 DVD player with TV tuner. The player/tuner will mount in the overhead cabinet on the right. The player is really small only 8.66 X 6.29 X 2.59 inches it is 12 volt and plays DVD, VCD, DVCD, SVCD, CD and MP3 disks. It has a remote and a remote sensor so it can hide in the cabinet. I ran the antenna/cable TV coax from the amp up inside the wall and then over the entry door to the cabinet and the player.

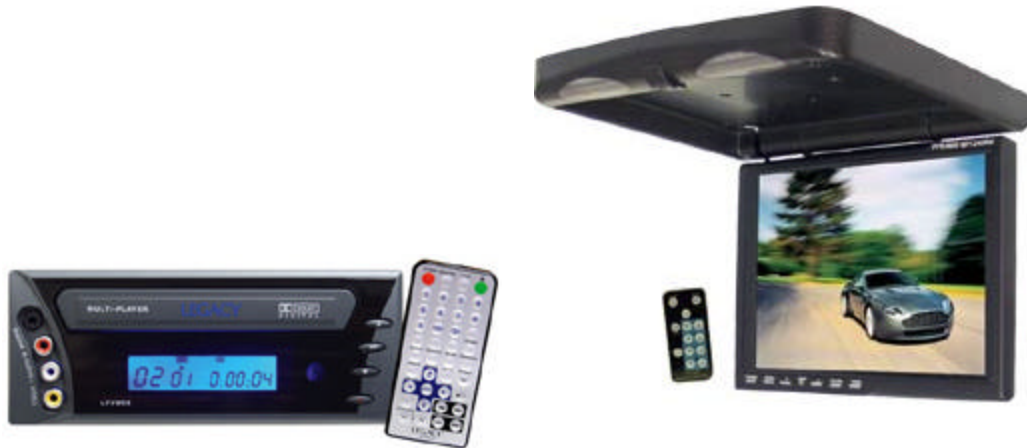
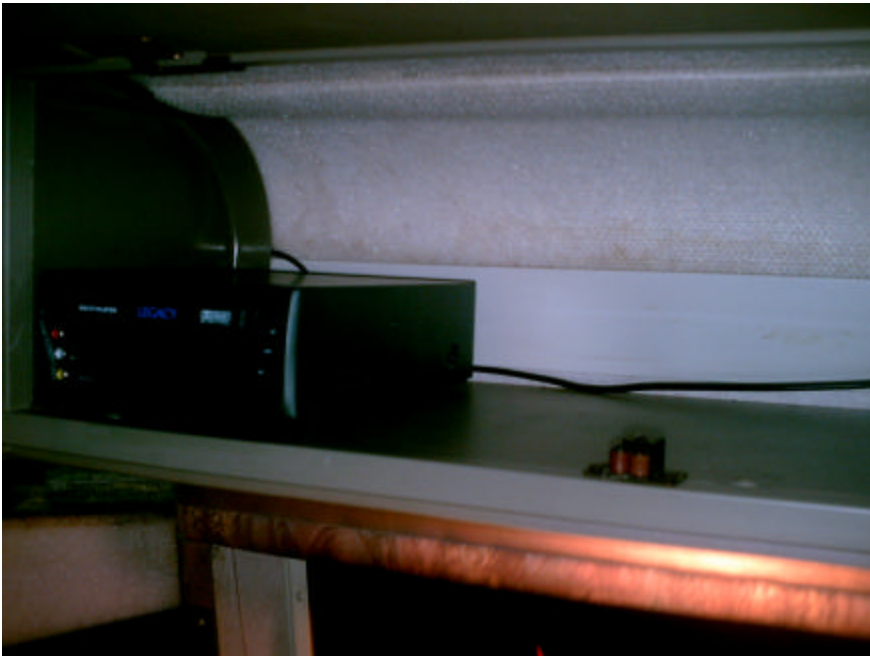
The player has AUX inputs for games, iPod, etc. I am installing a creative surround sound system with a subwoofer for the TV audio. This should keep us entertained on the road or at the campsite.

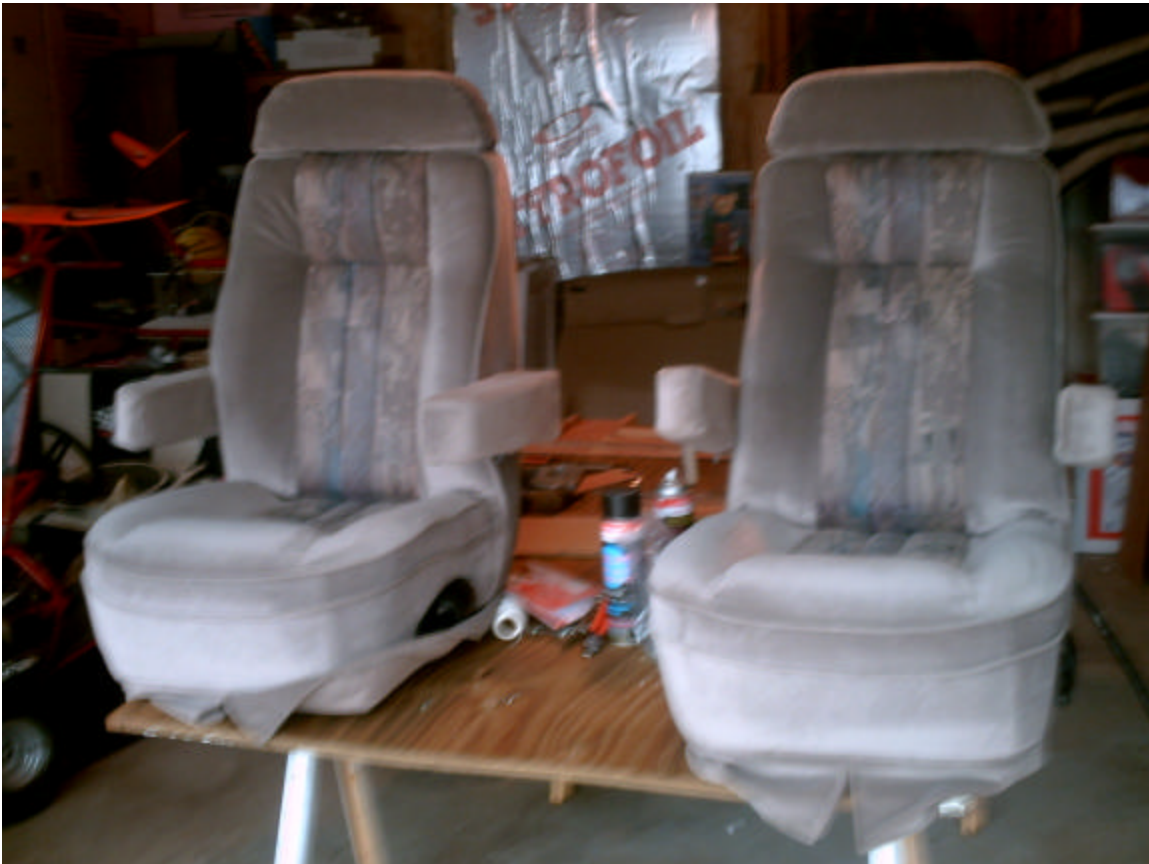
As part of my makeover I am redoing the upholstery. The front seats had seat covers on them so the fabric was in excellent shape. But as with most seat covers all the dirt had just filtered thru the covers and covered the seats. Also the covers were on so tight that they had mashed the headrests out of shape. I removed the seats and removed all the upholstery. This is not that hard to do you just need some pliers to remove all the metal hog rings that attach the fabric to the seat frame. We also removed the fabric from the

arms and the headrests. The plastic guides for the headrest should be removed also, they just pop out. We washed the fabric and repaired some tears where the fabric had been attached to the frame. The upholstery had been glued to the foam seat bottoms. This glue had pulled free causing the seat to lose its shape. We re-glued the bottoms with spray contact glue and tightened up the fabric with some extra padding. We also added padding to the head rests to return them to their proper shape. Using new Hog rings and a Hog ring tool I reattached the upholstery. It may be a good idea to take some pictures of the seats before you remove the fabric (if you have never re-upholstered before) as a reference to how it all goes back together. These seats are fairly simple the only trick is the tuft in the seat back. It has a piece of fabric that gets pulled thru a slot in the seat back and pulled down the back and fastened with hog rings to the seat bottom. This pulls the material in to give it a pillow look. It also tightens up the seat back upholstery. Just pay close attention to "HOW IT COMES APART" and you will find it is not that hard a task.

The seats look better than new and are ready to be reinstalled. The rest of the seats are in great shape also, they just need a good steam cleaning with the Bissell steam cleaner. The seats will also get a Scotch Guard coating before being reinstalled.

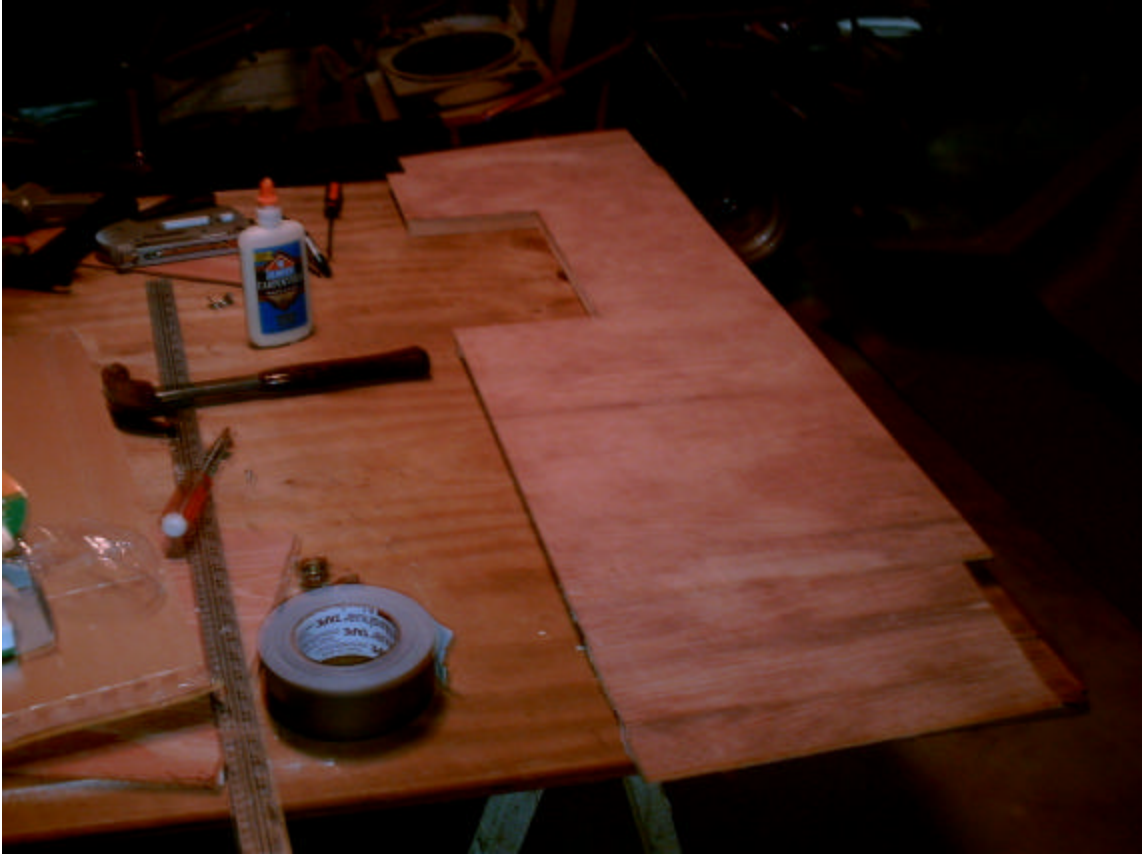
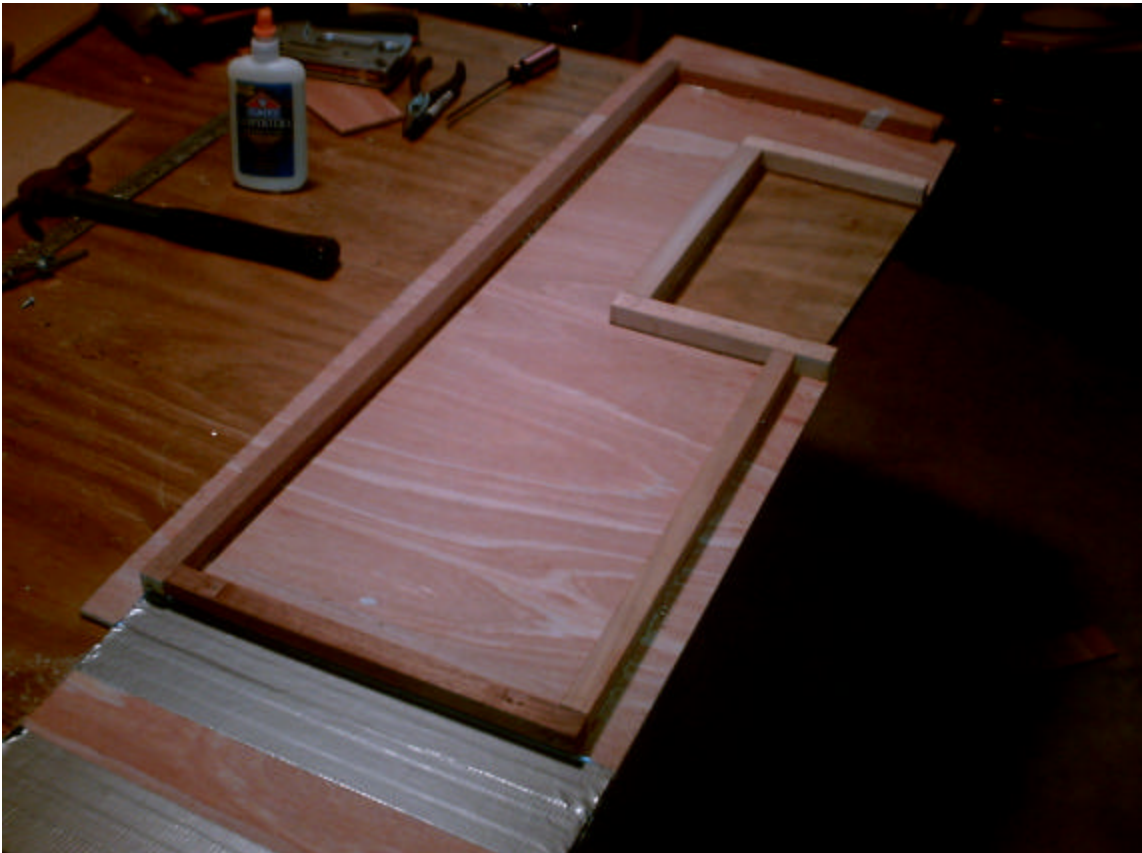
The kick panels under the rear dinette were stained and badly worn. These panels are made from cardboard and covered with fabric to match the seats. I have made new ones from 1/8 inch plywood and covered them with vinyl that matches the carpet (a dark Brown).

The duck tape forms a hinge for the left side panel. The plywood is much stiffer than the cardboard so it stays in place without the metal clips it just wedges behind the power

panel and the seat frame NO MORE SCREWS! The other side is held in place with a piece of Velcro at the top center.
