Installment 2 of "This Old Rialta"

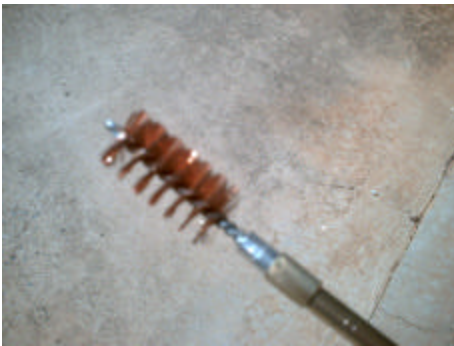
Cleaning tool

I finished refurbishing the refrigerator, cleaned the burner and rifled out the heat tube with a shot gun cleaning tool. I also checked the cooling fan and its thermostatic switch.

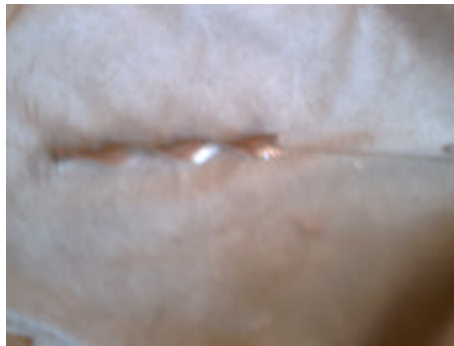
Heat deflector removed from tube

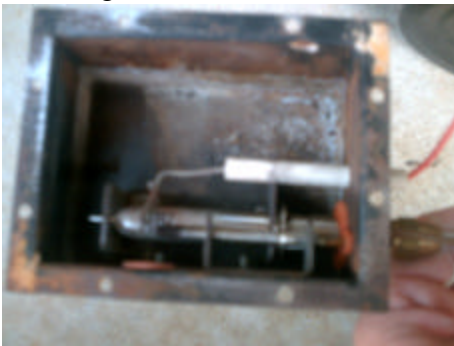
Burner assembly

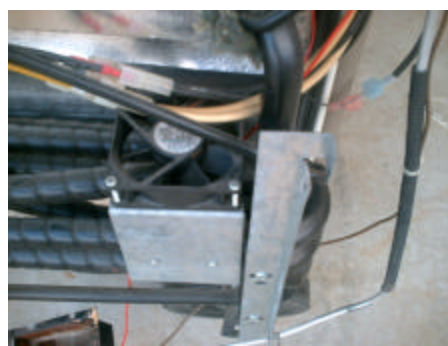
Cooling fan

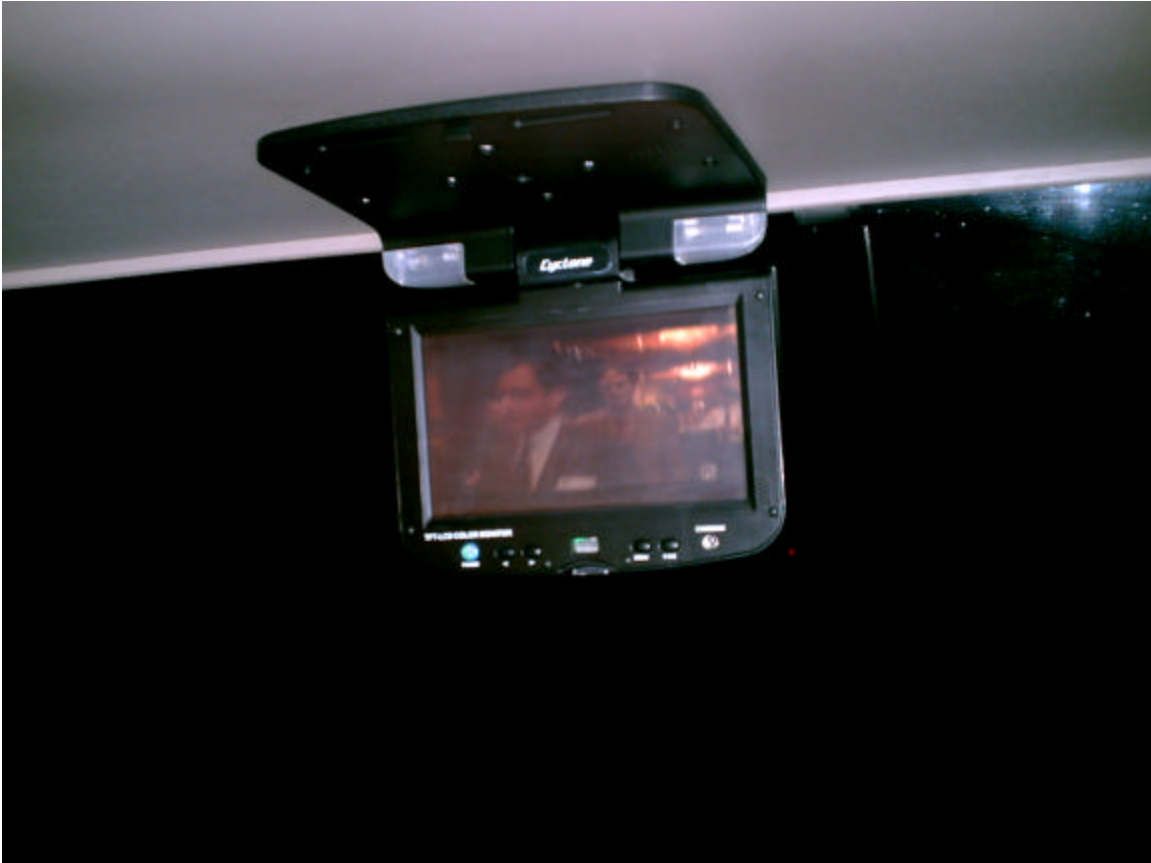
The second monitor for the rear arrived so I installed it and connected it to the DVD/TV tuner. This is an 8 inch monitor that swivels and retracts flat out of the way. It also has a dome light that will help light up the table nicely. Still waiting on the large front monitor for the front it arrived last week DOA and had to be returned.

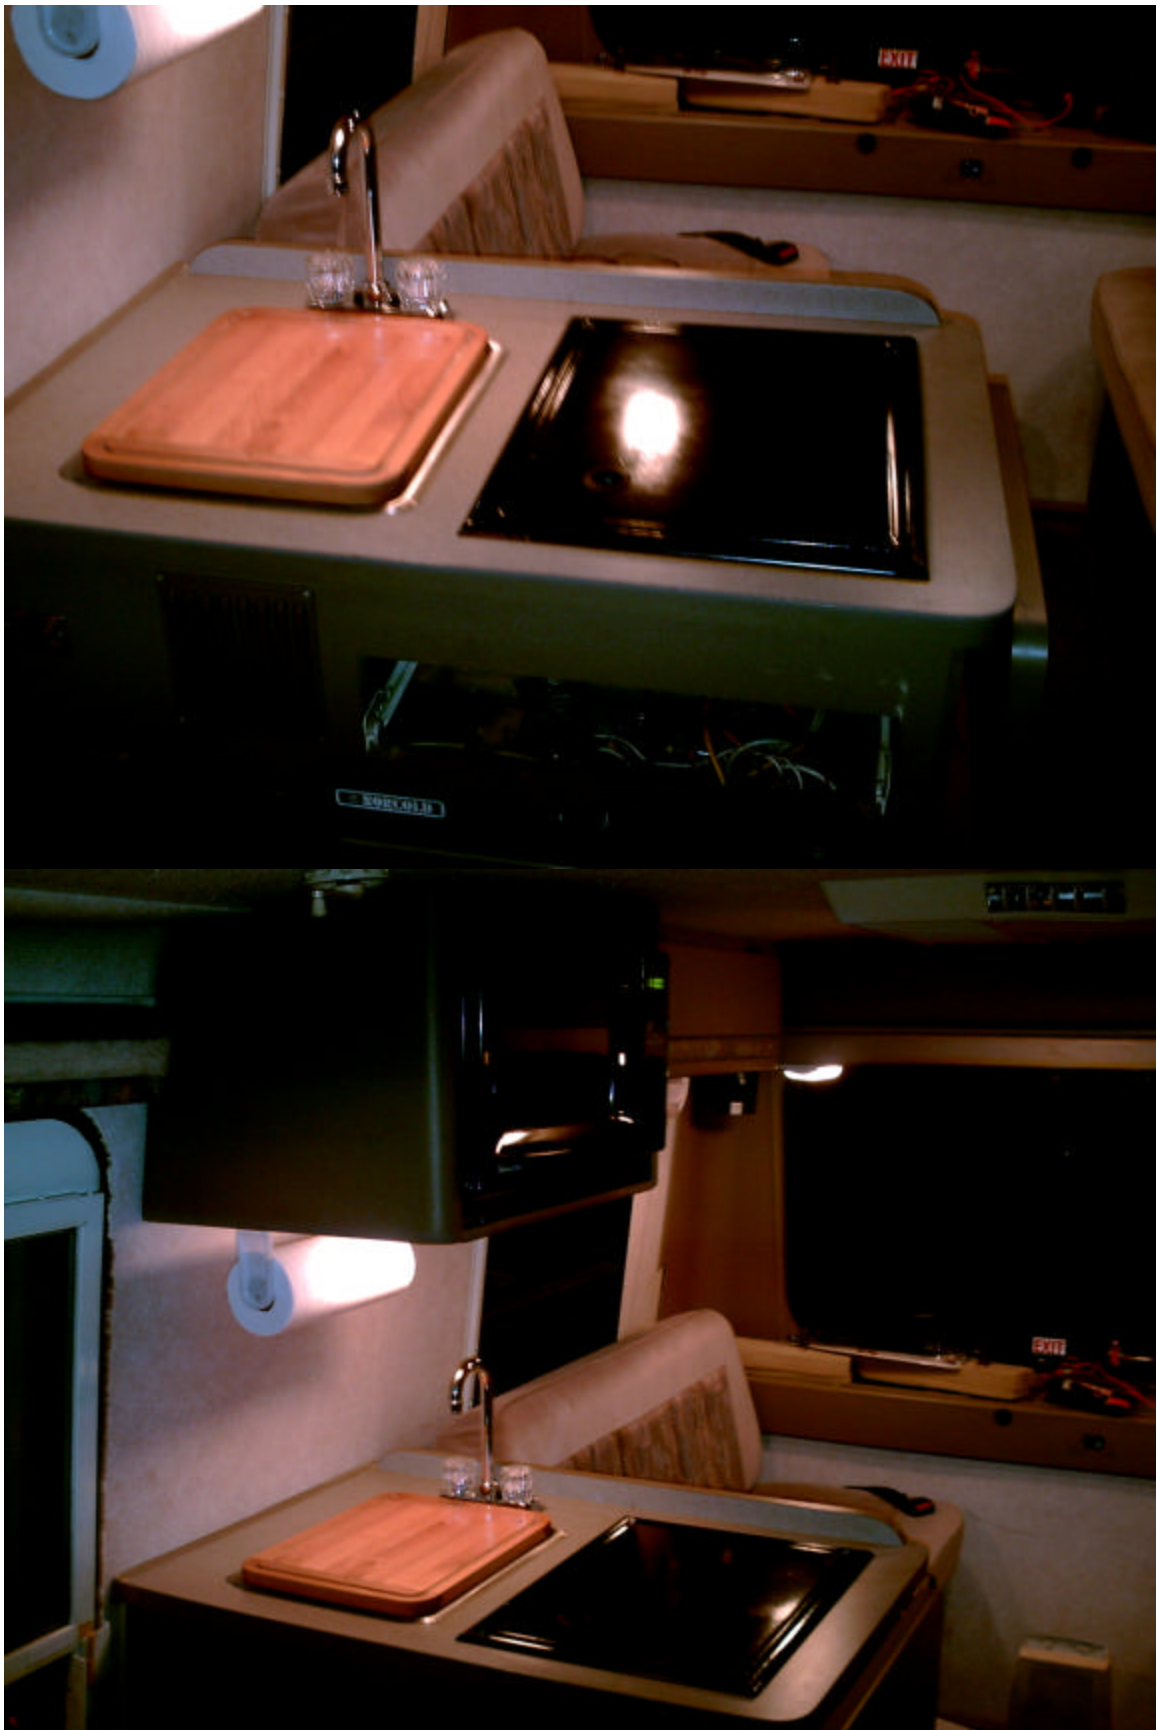
I removed the sink and cleaned it. It was installed beneath the countertop this is a nice feature on a solid surface counter but on laminate over pressboard it is a huge mess. Water works its way into the edge around the sink lip and swells the pressboard. I reinstalled it on top and added a new bar sink faucet. The stove was in good shape, did not appear to have been used much. I polished the stainless steel burner cover with rubbing compound this removed the rust spots and brought it back to a nice shine. I sanded and painted the mounting frame and the cover with gloss black appliance paint. Then topped off the sink with a cutting board and now the cooking area looks like new.

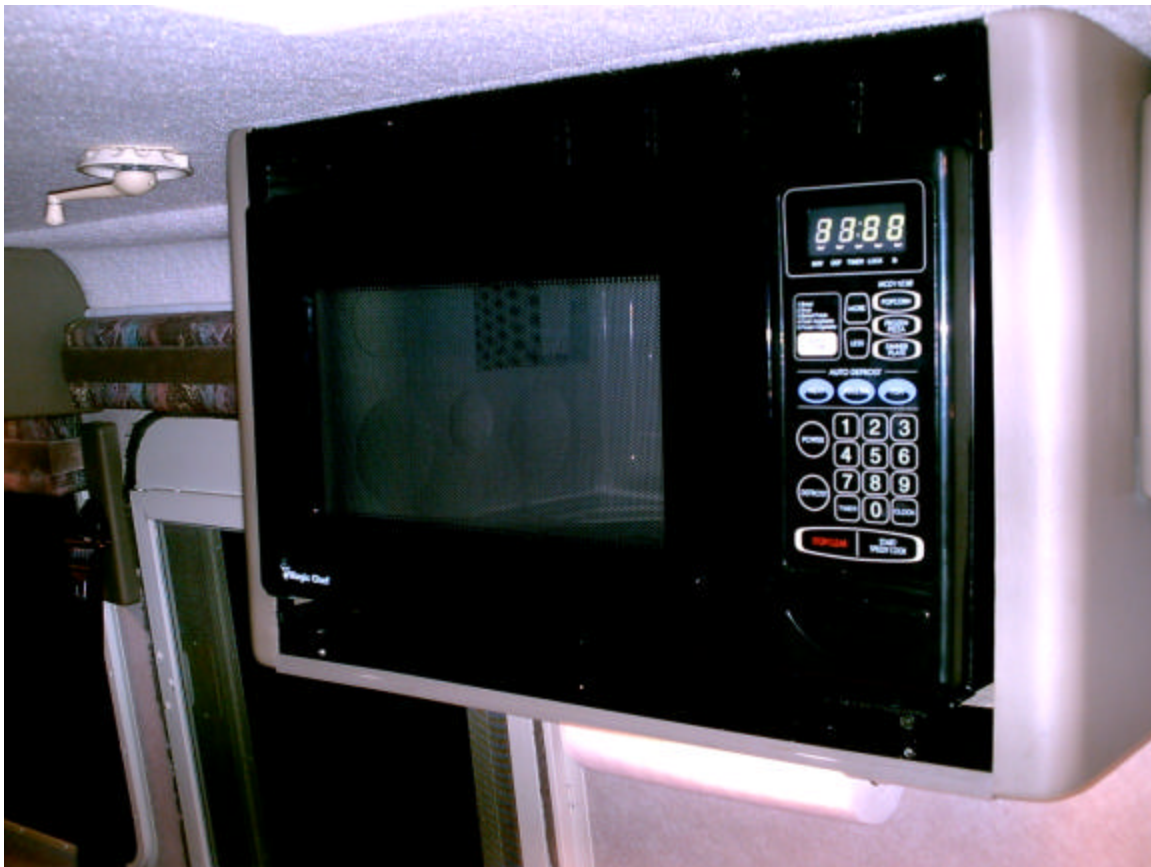
Next up was the Microwave. The old one was in bad shape the control panel was broken and it looked like it had a small fire inside at some point. I found a Magic Chef Model MCD11 1.1 cubic foot that was almost identical to the original. It was about ½ inch narrower, ¾ inch shorter and an inch deeper. I had to install two ¾ inch strips of plywood in the bottom of the cabinet and move the plug from the back wall to the bottom. I removed the deflection and mounting ducts from the old unit and installed them on the new one. The old case had an exhaust hole in the top; the new one has them in the side. I removed the cover of the new microwave and cut out a hole to match the old one and duck taped the side vents closed. The old trim fit the new case perfectly and the finished product looks like it came from the factory.

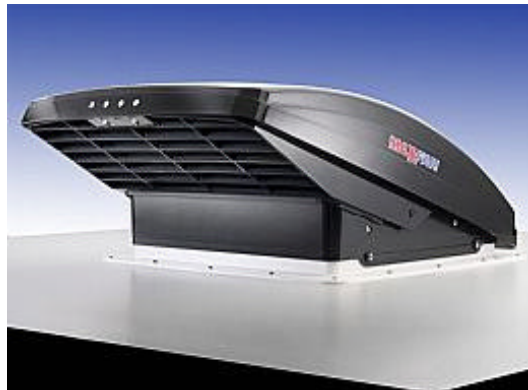
I think every fan on this thing was broken, the Fantastic Vent made a racket on high so I pulled the motor on it and the bearings were toast. I could have ordered a new motor (it uses a standard Fasco type) but while browsing the net I came across the new MaxxFan Ventilator. It cost a little more than the fantastic vent but you don't need a Maxx Vent Cover and all the issues that go with those things. It has a thermostat, 3 speeds and a reversing fan. It comes in white and smoke I opted for the smoke to cut down on the light up front and it can be fully opened when the vehicle is moving. All that and it looks DEAD SEXY!
