Installment 3 of “This Old Rialta”

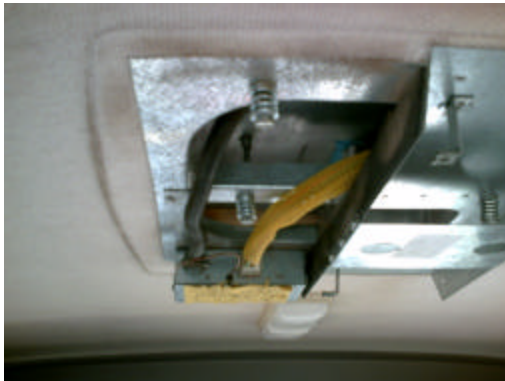
Before

The ceiling of the Rialta is covered with a carpet like fabric and ours was nasty in spots. The fantastic vent had leaked and left a brown stain around it and the A/C had blown dirt out the sides and the vents to leave black areas. Also the plastic A/C shroud had yellowed and looked bad against the white ceiling. Solution I removed the A/C shroud and the vent trim then using a Bissell Steam Carpet Cleaner upholstery attachment I cleaned the ceiling. I then cleaned the shroud and painted it with Krylon Plastic Paint. This paint is specially formulated for plastic and bonds to it extremely well.

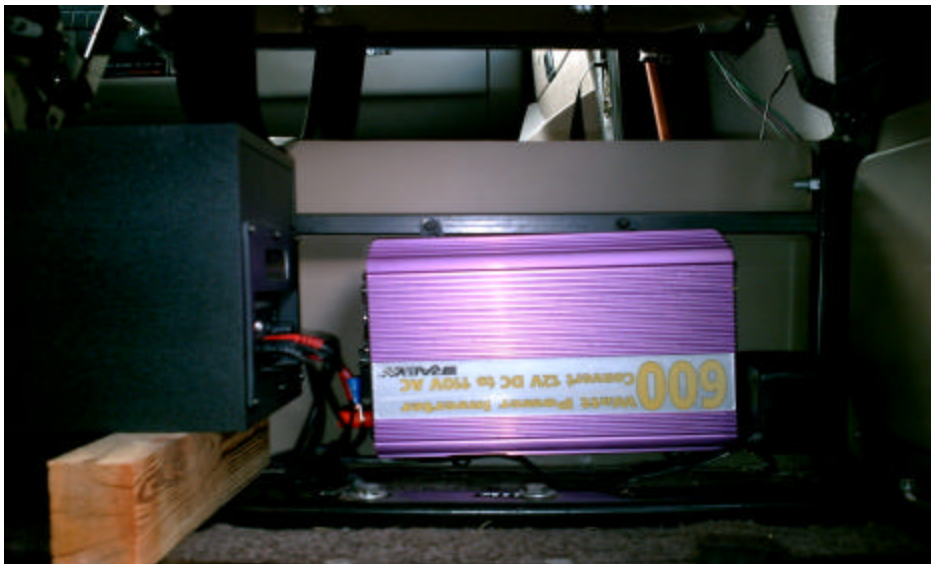
Next project install the inverter to power the surround sound system. I located the inverter under the right rear seat along with the Amp/Subwoofer. This worked out great, you can reach the on off switch by reaching thru the opening just under the seat. This supplies some good ventilation to the inverter and its close proximity to the battery compartment made the wiring simple.

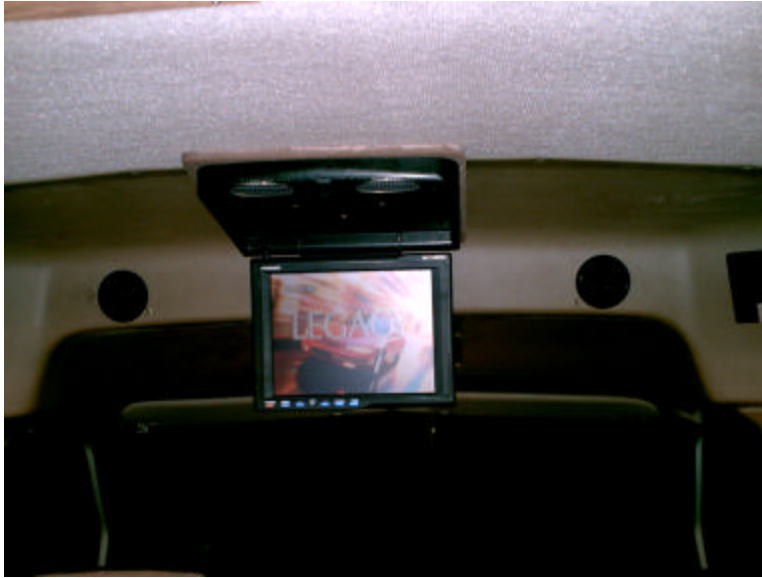
Opened

The replacement LCD TV arrived and I fashioned a mounting base out of plywood and covered it with some of the fabric I had removed from the kick panels under the rear seats.

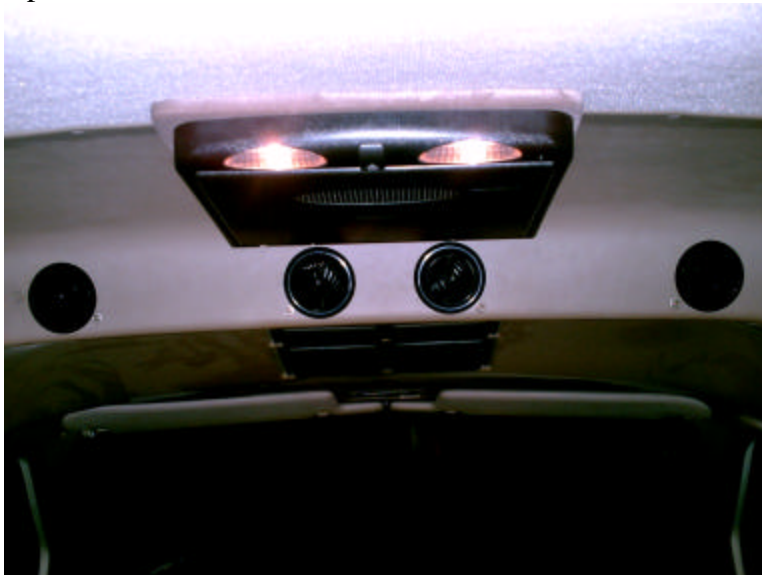
Closed, it even has dome lights.

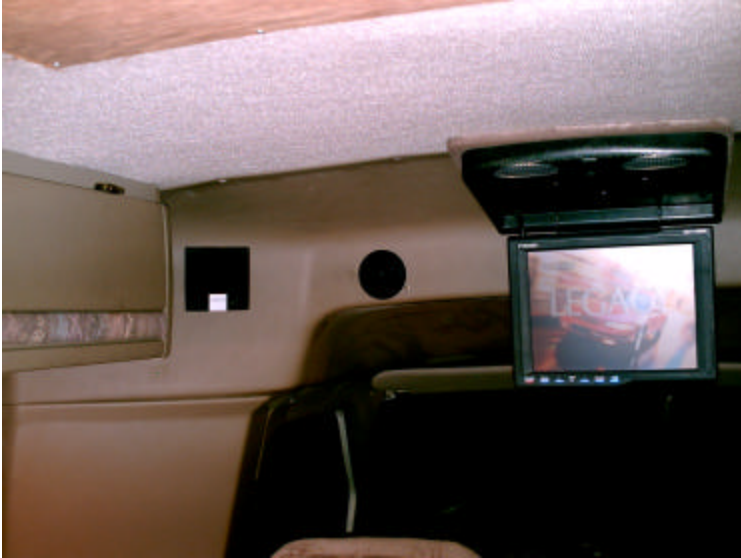
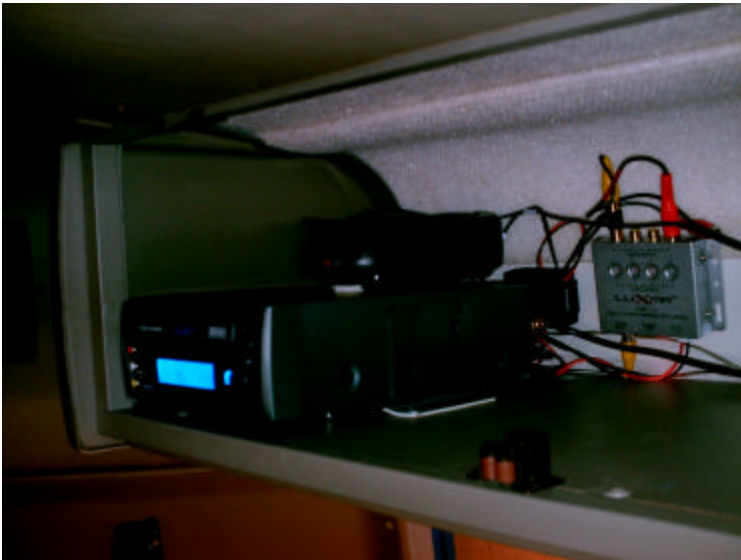
The DVD/CD/MP3/TV tuner and the X10 camera receiver are all mounted in the front cabinet. The box on the wall is the video distribution controller that feeds the front and rear video screens, both screens play the same video or the rear one can show the X10 cam feed.

Mounted the speaker cubes in the front (there are 4 of them 2 more in the rear) and reinstalled all the panels and the headliner. I found some large holes behind the transition panels and I plugged these with spray expanding foam ("Great Stuff"). I added some additional insulation to the ceiling and behind the wall panels.

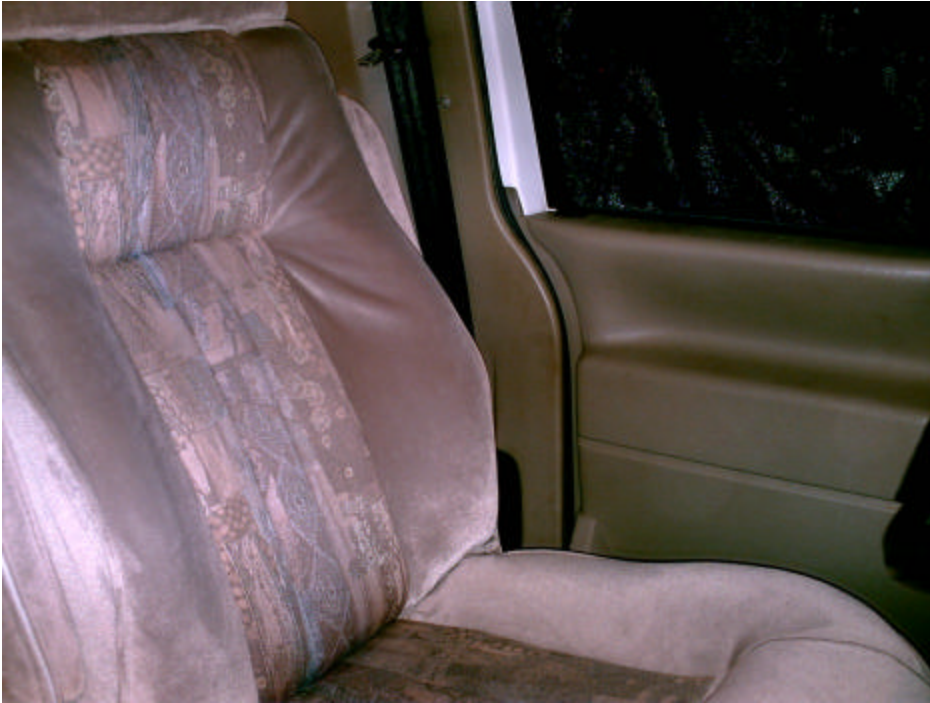
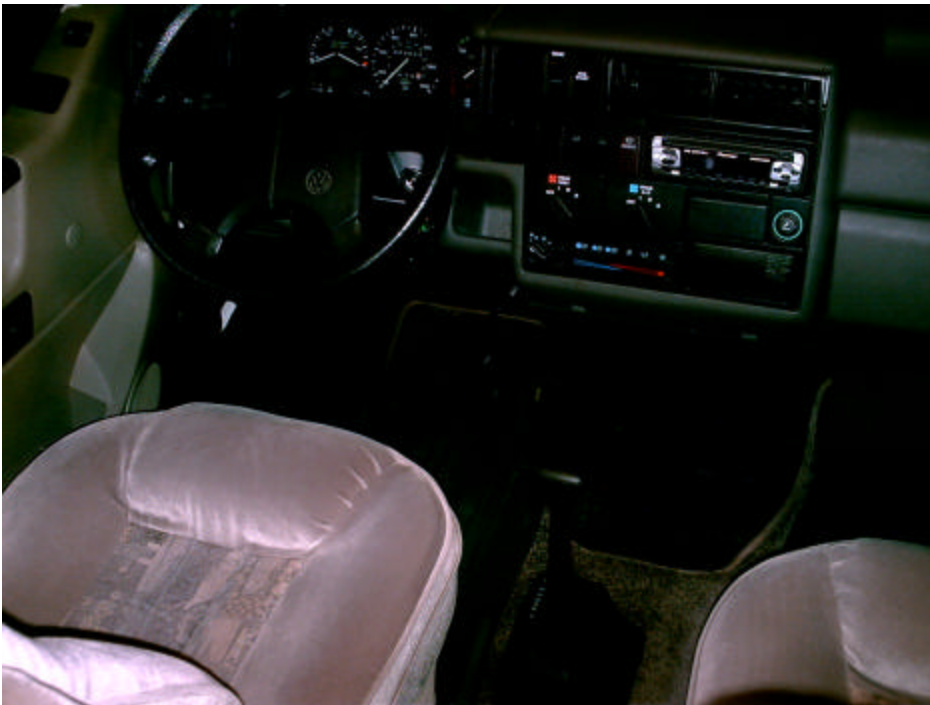
I had removed the carpet in the cab, this allowed me to clean the floor mat you would not believe what I FOUND UNDER THAT CARPET! With it removed it was easy to steam clean it with the Bissell. I reinstalled the refurbished seats and gave the rubber floor mats a good scrubbing. And Presto (only 4 weeks later) we have an interior that looks as good as new.

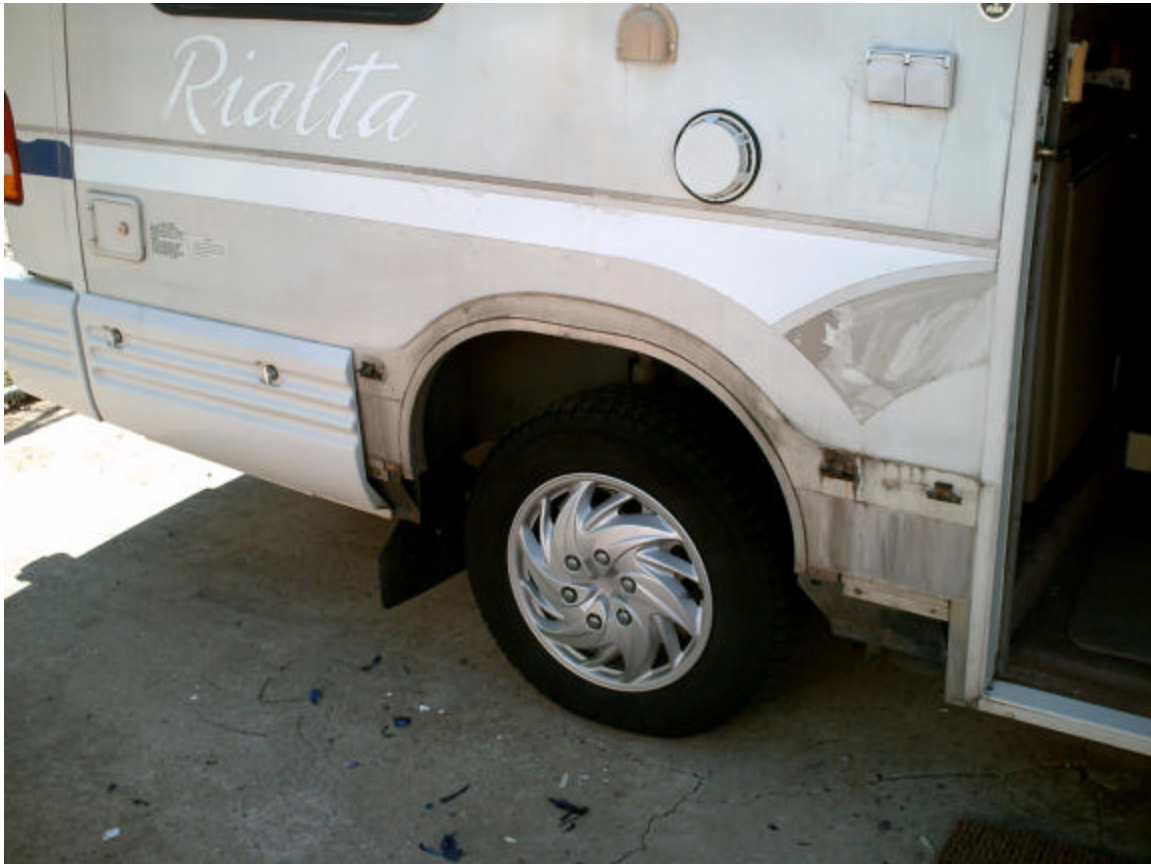
IT IS IMPOSSIBLE TO REMOVE THE STRIPES ON A TEN YEAR OLD RIALTA! I tried all the tricks, let it set in the hot sun...Nuttin! Used a heat gun...this helped got the blue stripe at the back to peel but it left behind the plastic backing.

Tried some "Goof Off" ... This stuff works great melted the stripe and the plastic backingAND THE PAINT!!!! The paint on this thing is split frog hair thin and it has no primer behind it! So out came the orbital sander! Stripes GONE!

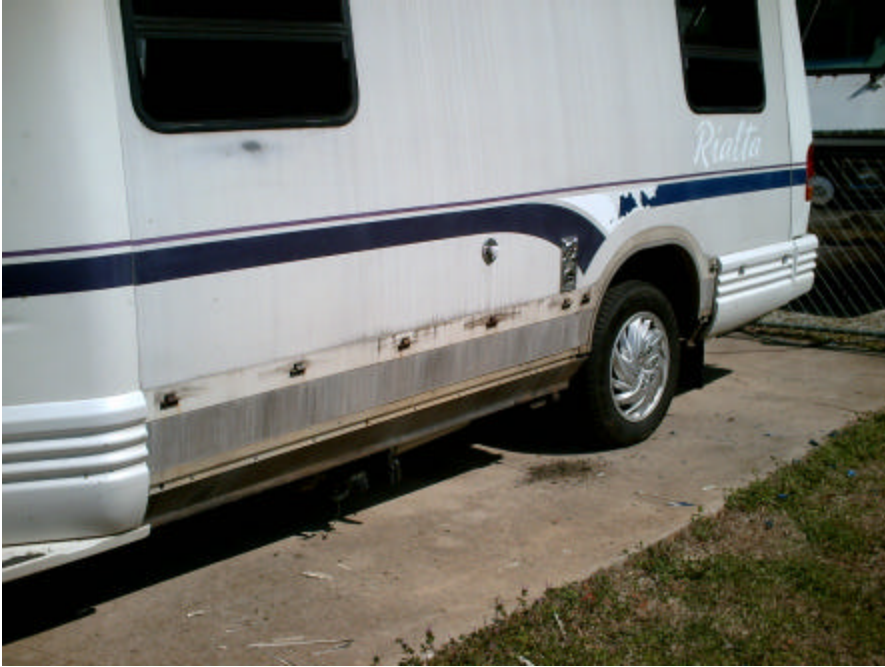
There was some damage to this skirt not much just some scratches. The skirts are held on with some screws at the bottom and clips at the top. Remove the screws and lift up on the panels (It may take more than a gentle lift rubber hammer works good)

My plan now is to repaint the coach body and just compound and polish the front and the rear. The cab paint is in great shape and the fiberglass caps will polish back to new. I removed all the plastic skirt panels (had some minor damage to one section) and will paint them a dark metallic blue to replace the blue stripe. I have ordered enough of the front striping to redo the body sides and the back. As you can see in the pictures the body had a grey tint to it partly because of the infamous "Black Streaks" but mostly due to the thin paint letting the aluminum skin show thru. The roof paint is totally gone the sun and lack of cleaning and waxing has taken its toll. So off with all the roof hardware, A/C, New Maxi Vent, Antenna and plumbing vent stack. The real fun here will be cleaning up all the excess caulking smeared all over the roof. All the windows will be removed as well as the door and anything else that's needs paint behind it (This won't be no MAACO paint job).
