Final Installment of “This Old Rialta”

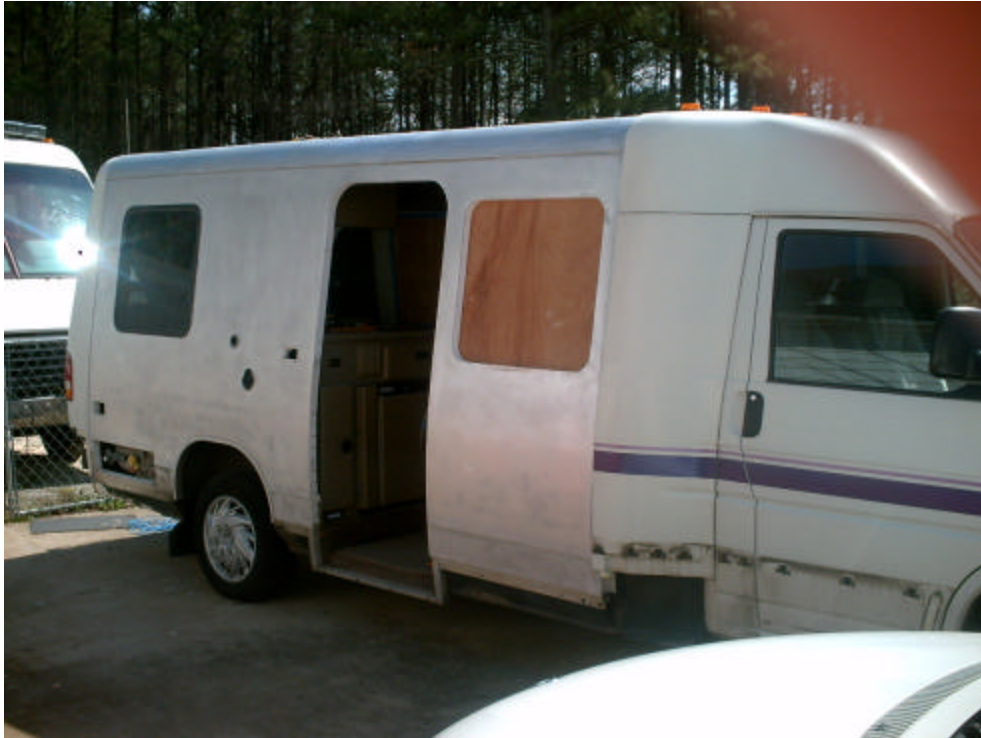
The first step in the paint process was to remove everything on the outside of the motor home that would come off. All the windows, Doors, Roof AC, Roof Vent, all lights, fillers, plugs and all of the plastic skirt including the front and rear bumpers.

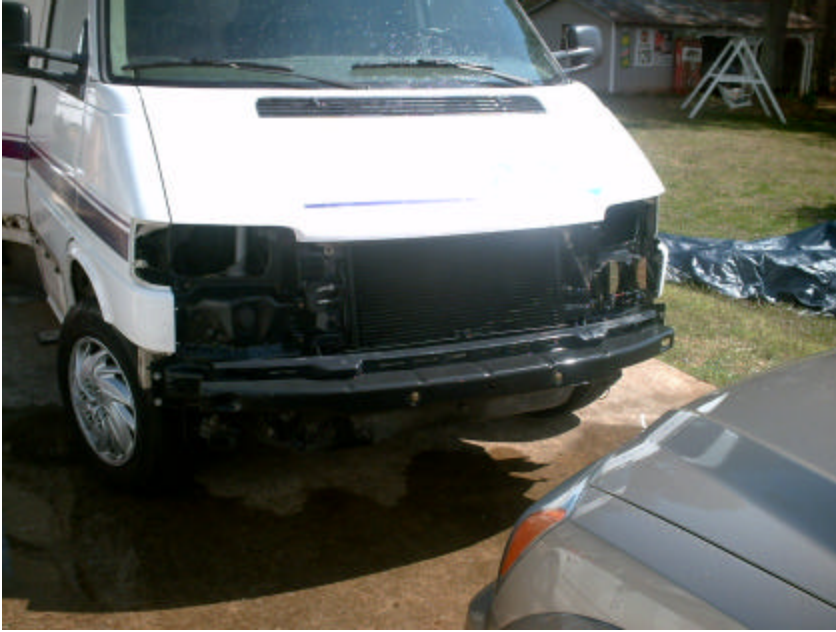
Then it was time to SAND! SAND! SAND! I hand sanded the body (The body and roof panels are aluminum) using an orbital sander and 150 grit paper. After all the paint was removed I filled all the dings and cut out the new openings for the exterior shower (we did not have that option on our 95) and the new water filler opening. I moved the city water connection to the same side as the fresh water tank filler. I found a hatch that contains both behind a lockable door. This was necessary to make room for the external shower. The shower compartment is a one piece molded plastic box with a lockable door. I painted the boxes and the doors to match the body. The entire body was then sanded with 300 grit paper in final prep for paint.

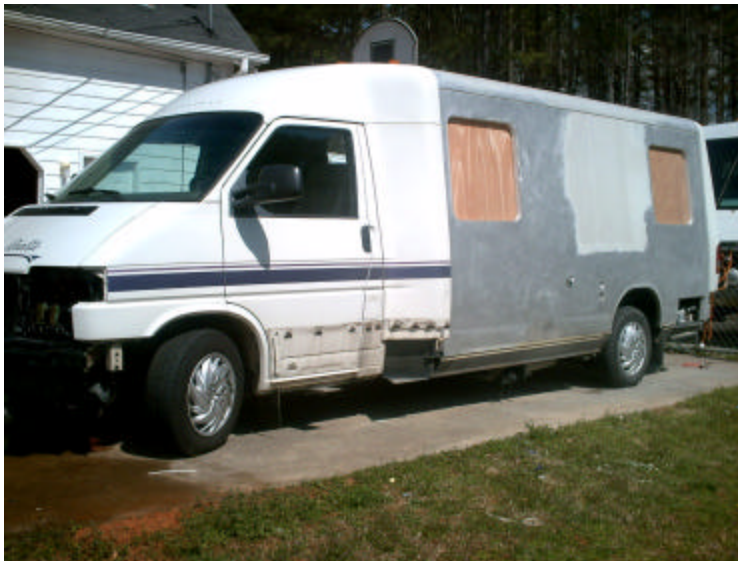
I pressure washed the area behind the grill while I had the front apart for paint. The AC condenser was packed with bug carcasses and dirt. And the areas behind the head lights had all sorts of nests and critter remnants. Since the paint on the cab was in good shape I only had to buff it out to get a like new finish back on it.

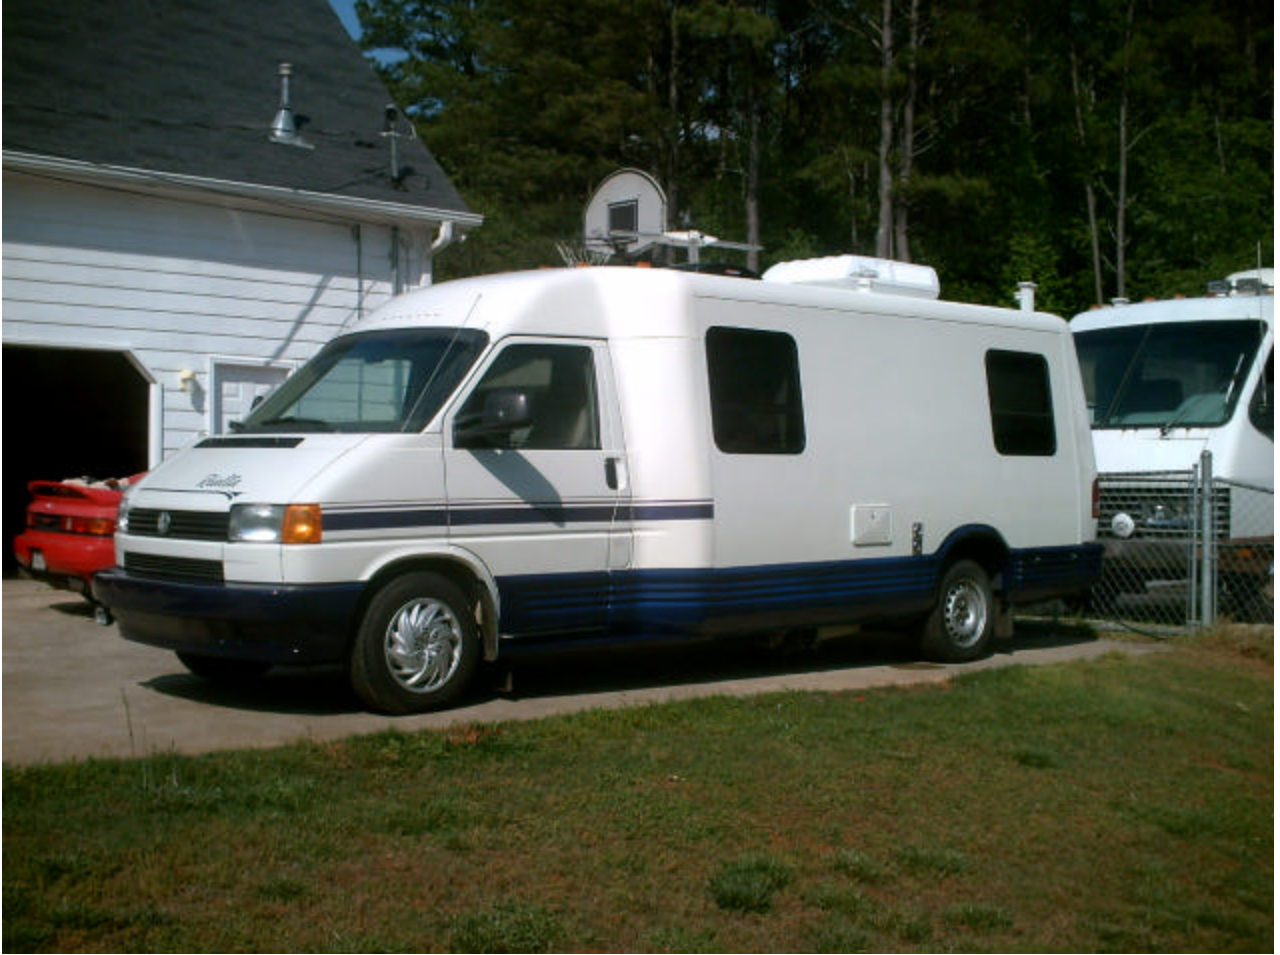
Then after a few more weeks of masking out, sanding, filling, priming, sanding, rubbing, wiping down, cussing.....Painting!

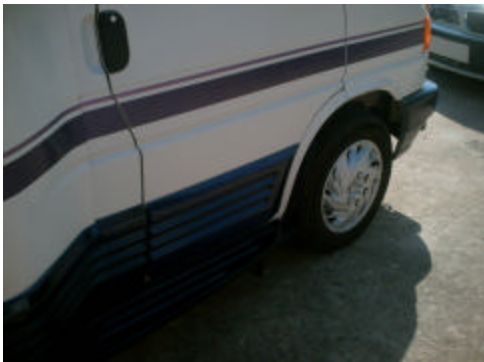
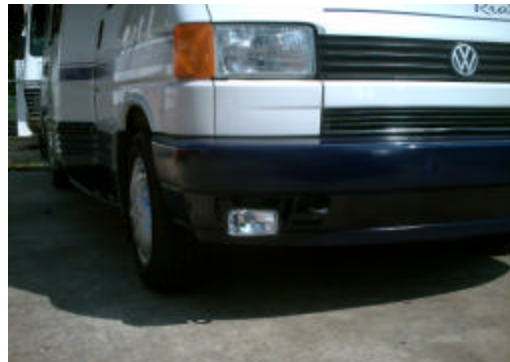
While I had the windows removed I sanded them and painted their frames, repaired any missing parts or broken operators as well as replaced all the screens with new material. This extra bit of work really adds to the clean look of the new exterior. All we lack here are some stripes The original stripe sets are not available for the 1995 model anymore only the straight 2 part purple stripe for the front can be found. So I ordered enough to re-stripe the entire coach in just the single stripe. I also mounted some nice driving lights on the bumper. They fit perfect in the recess where the factory driving lights should go.

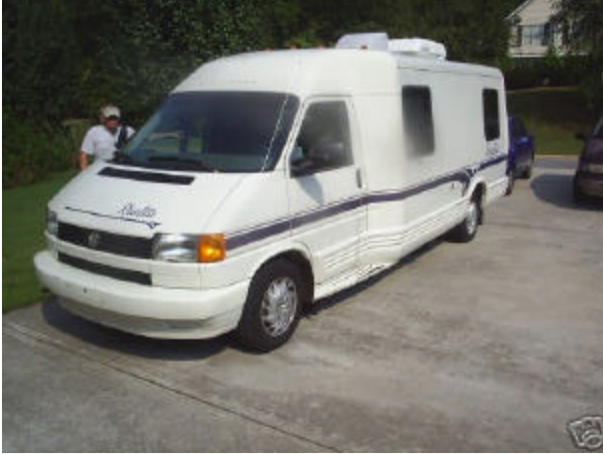
BEFORE

(This is the e-bay add photo I bought it from)

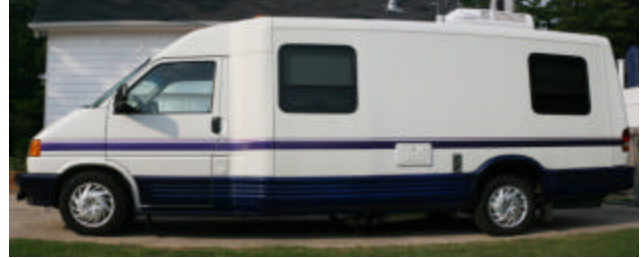
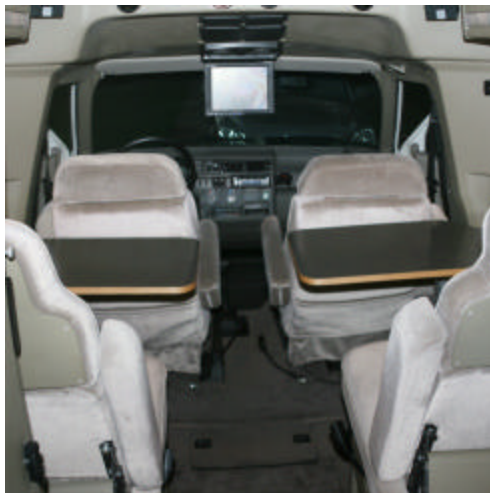
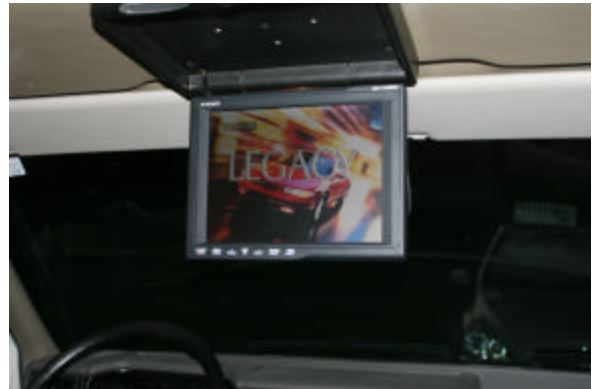
AFTER

(The dark blue on the skirt changes color in the sunlight)

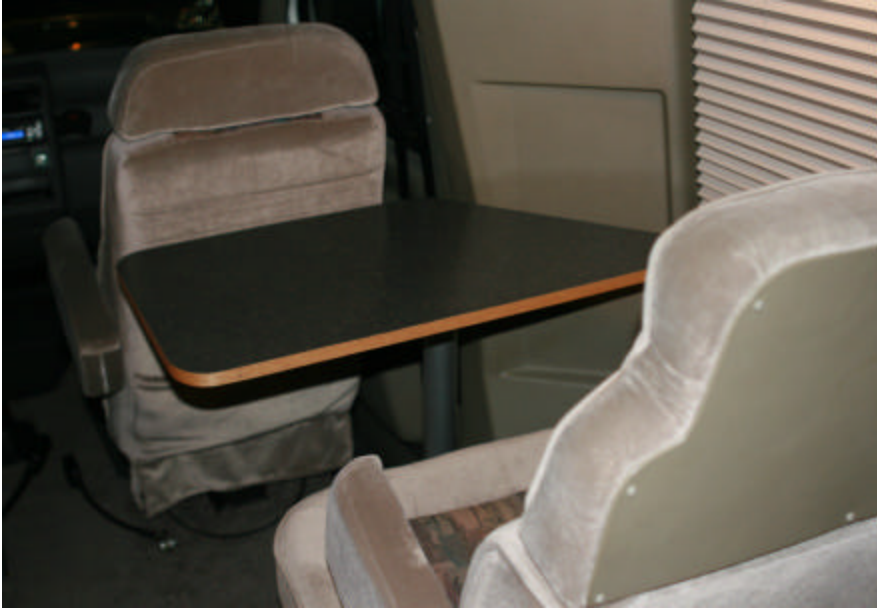
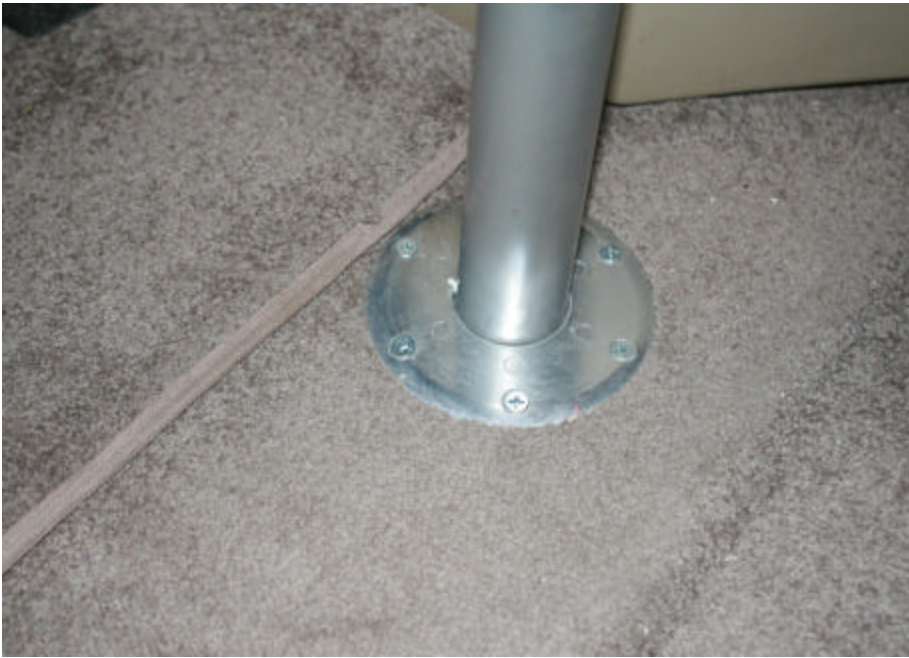
After some deliberation I decided to move the overhead TV forward into the cab. This allows for a better viewing angle from the jump seats. LCD screens are best viewed straight on not from the side so by moving the monitor forward the picture is much clearer. I wanted some type of table to put my laptop on and to have a place to sit and watch TV and munch out. I picked up some recessed table mounts and the post that goes into them. I made 2 table tops from $\frac{3}{4}$ plywood, these are cut to fit behind the driver and passenger seats. I put laminate tops on the plywood and oak veneer on the edges and added the leg receptor to the bottom. I then cut a hole in the steel floor just behind the front seats offset to the outside of the coach. There is plenty of room in this area without getting into anything underneath the cab (like gas lines or tanks and such). Mounded the recessed table leg receptor in the hole (I put a lot of silicon around the receptor to seal out any water or fumes from the underside of the Motor home. This made a nice set of tables that can be stored in the area beside the jump seats when not needed.
