On my last trip I noticed that when I emptied the bathroom sink the water spilled out and ran down the back wall. This happened because the rubber strip was missing on the front of the catch basin behind the sink. I found the rubber strip in the bottom of the catch basin it appears that the glue did not stick very well to the plastic basin. I know a lot of Rialta owners have this same problem so I decided to find a more permanent solution.

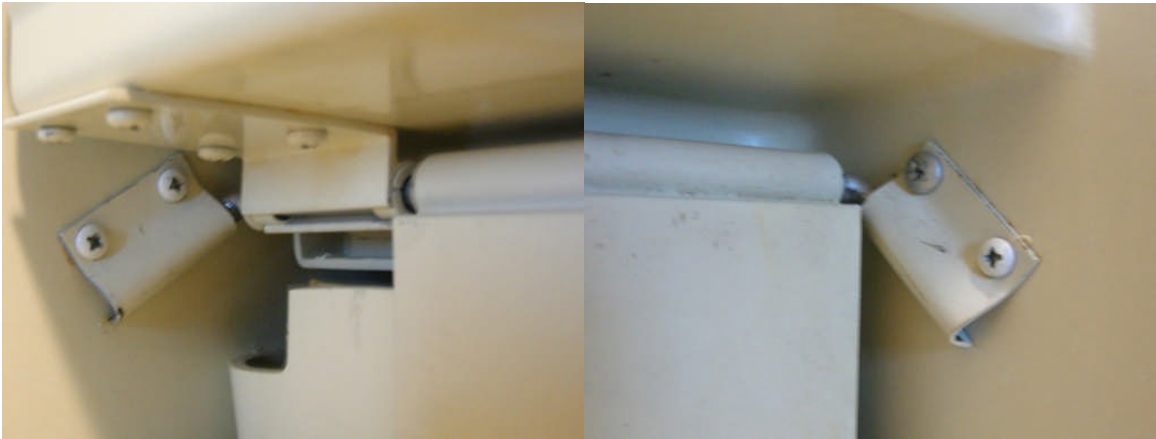
To install the gasket I did the following...

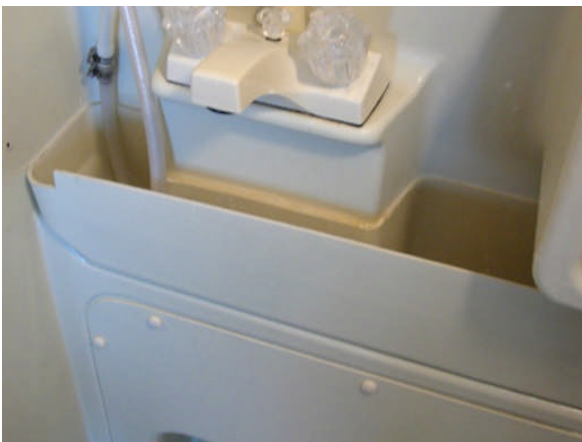
First remove the four screws that hold the fold down shelf and sink. There are 2 located on each side beneath the shelf. Then lift out the shelf and sink.

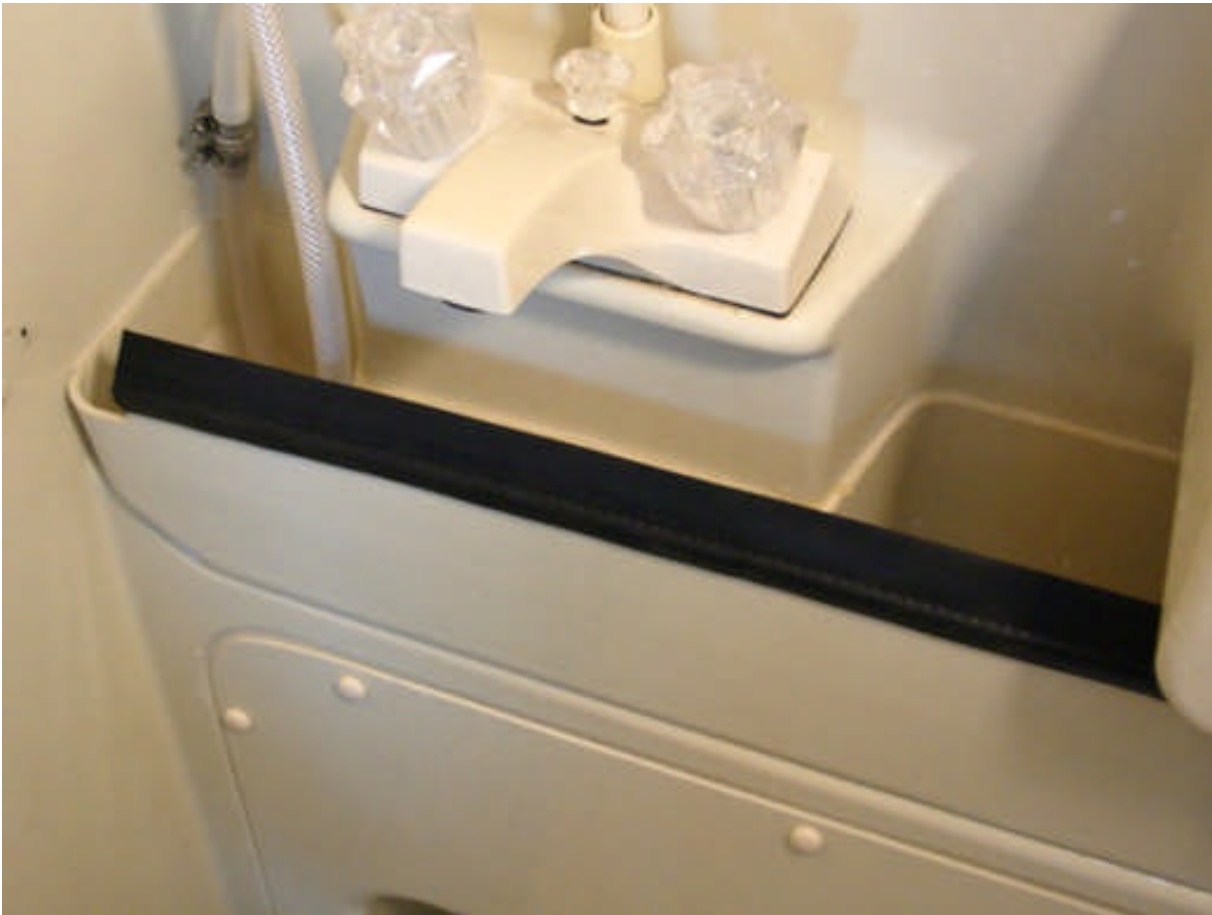
Now you can see the front edge of the catch basin and you will notice that mine is missing the grey rubber strip (Yours might not have it either if not you already know it!).

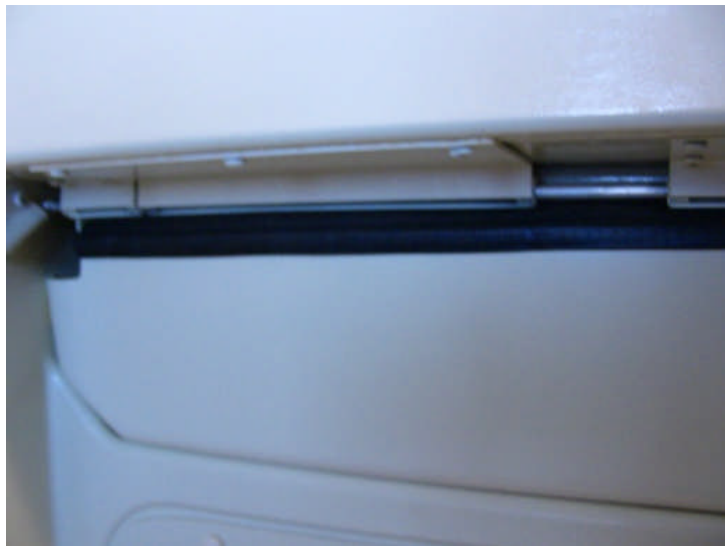
Next I cut the new gasket to length and pushed the U channel down over the plastic edge of the basin. It is a VERY tight fit so some firm pressure is required. THAT'S IT! Now replace the shelf and sink and NO MORE SPILLS FOREVER!

Once you replace the Shelf and sink the gasket will bend behind the hinge and fill the gap between the sink back and the catch basin.
